Streambank Erosion Control on the Winooski River, Vermont

FRANK C. EDMINSTER, Regional Biologist

UNITED STATES DEPARTMENT OF AGRICULTURE

OCTOBER 1949

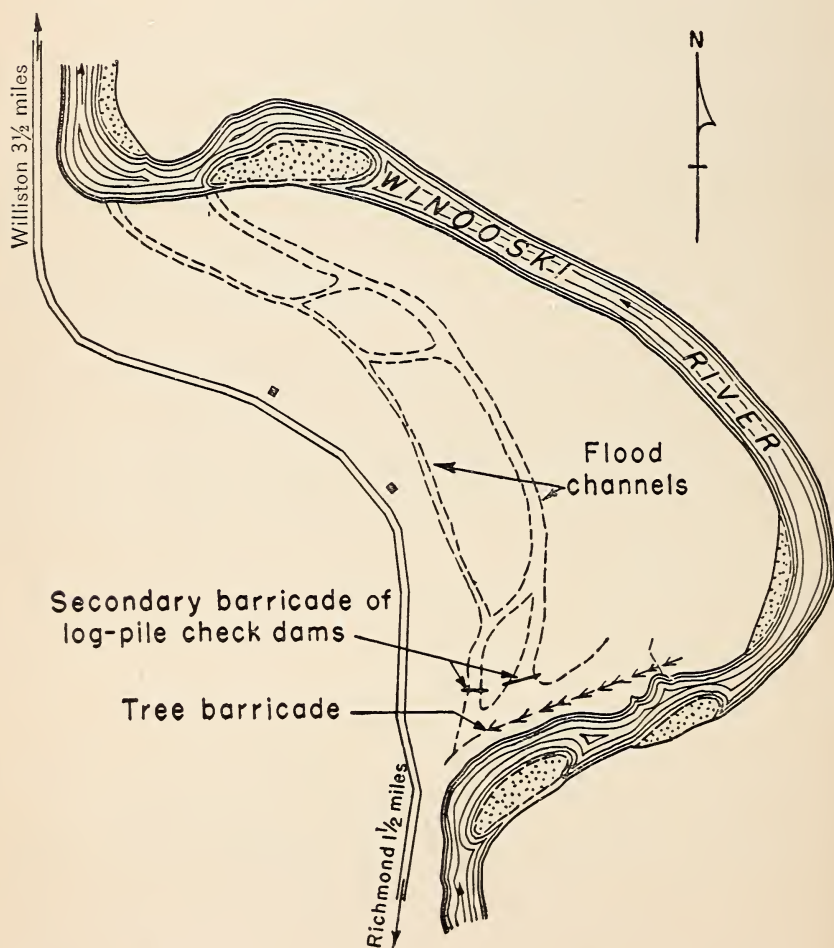
TREE BARRICADE AND LOG-PILE CHECK DAM WITH BROAD BUFFER AND FILTER PLANTING.—A temporary barricade about 7 feet high and 900 feet long was built on a section of the river where previous floodwaters had cut new channels through cropland (figs. 10 and 11).

FIGURE 10.—Map of section of Winooski River showing channels cut by flood-water and location of tree barricade and log-pile check dams.

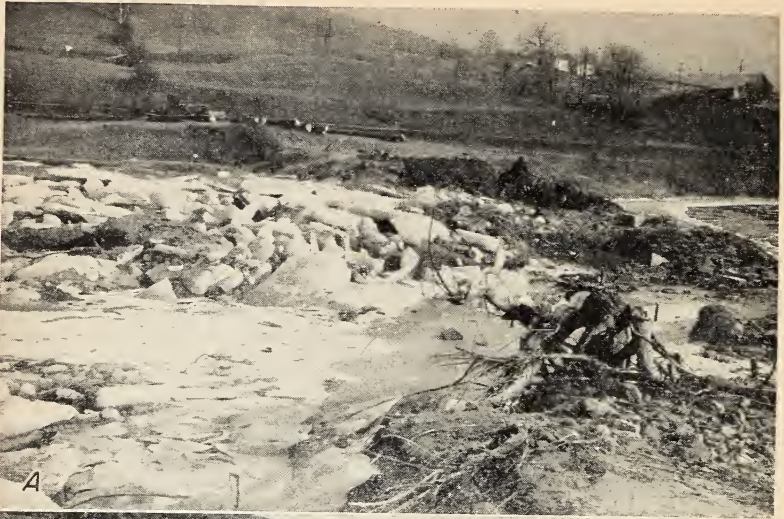
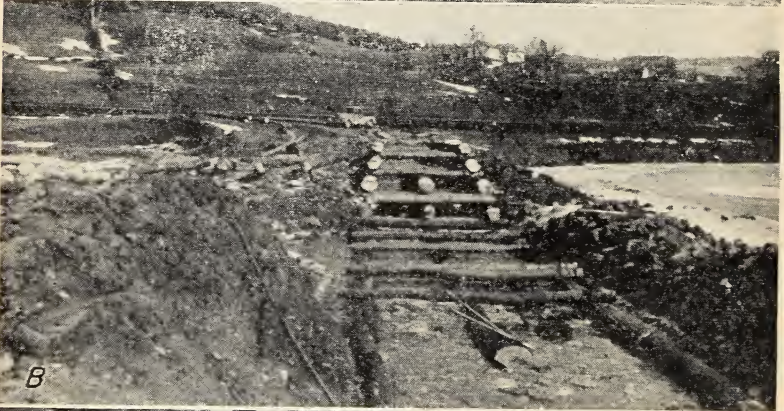
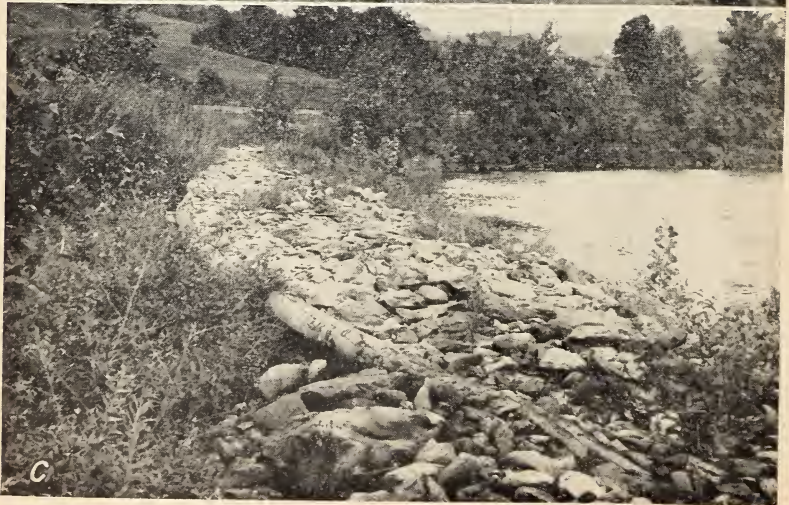
STONE-FILLED LOG CRIB WITH BUFFER AND FILTER PLANTING.—On the more severely damaged sections, stone-filled log cribs provided greater permanence of control than simple planting (fig. 16).

Trees were planted in a band 200 feet wide along the bank across the new channel parallel to the crib. The method of planting was similar to that mentioned in a later section under the heading, *Installing Tree Barricades*. The stone-filled crib greatly checked the velocity of the current and was still in good condition after 10 years. It had adequately accomplished the purpose for which it was constructed; namely, slowing the flow to the point where the trees could catch and hold the gravel and silt carried by the water. The crib will need minor maintenance until the logs rot, leaving only the stone. Additional plantings are needed on the field side and at the inshore end of the crib and in the channel in order to strengthen the buffer and provide the necessary protection after the logs rot. An adequate tree growth

FIGURE 16.—Stone-filled log crib with buffer and filter planting: A, Section of bank where the river cut a new channel across cultivated field, January 1937; B, crib under construction; C, completed crib 8 years later showing at left the growth of trees on field side of structure.

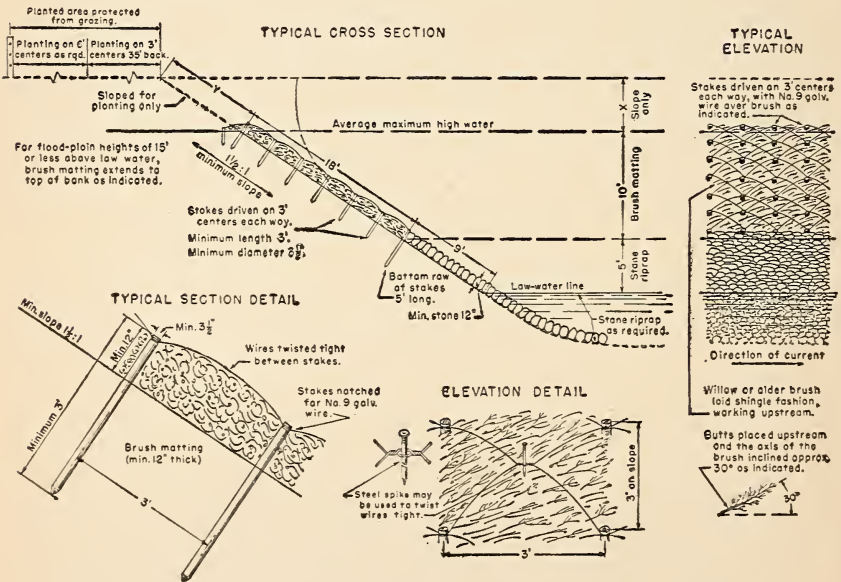
FIGURE 17.—Construction details of stone riprap and brush matting.

Figure 17 shows a typical plan for bank sloping, hand-placed riprap, and brush matting to be placed on the bank above the riprap to protect the shrub planting.

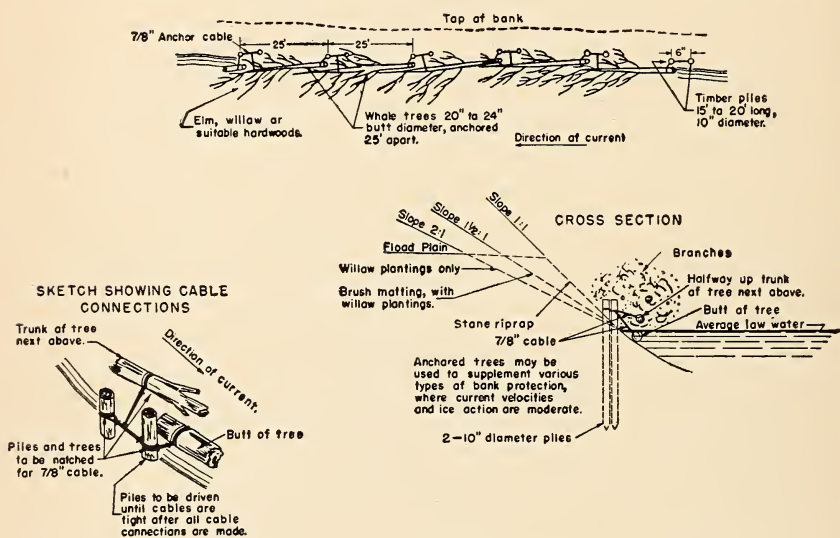
FIGURE 18.—Anchored tree deflector.

Tree deflectors, like tree "blankets," are pervious velocity-reducing structures (fig. 18), used chiefly where the water at the toe of the slope is very deep. They are considerably less expensive than riprap. Those installed on the Winooski were usually supplemented by brush

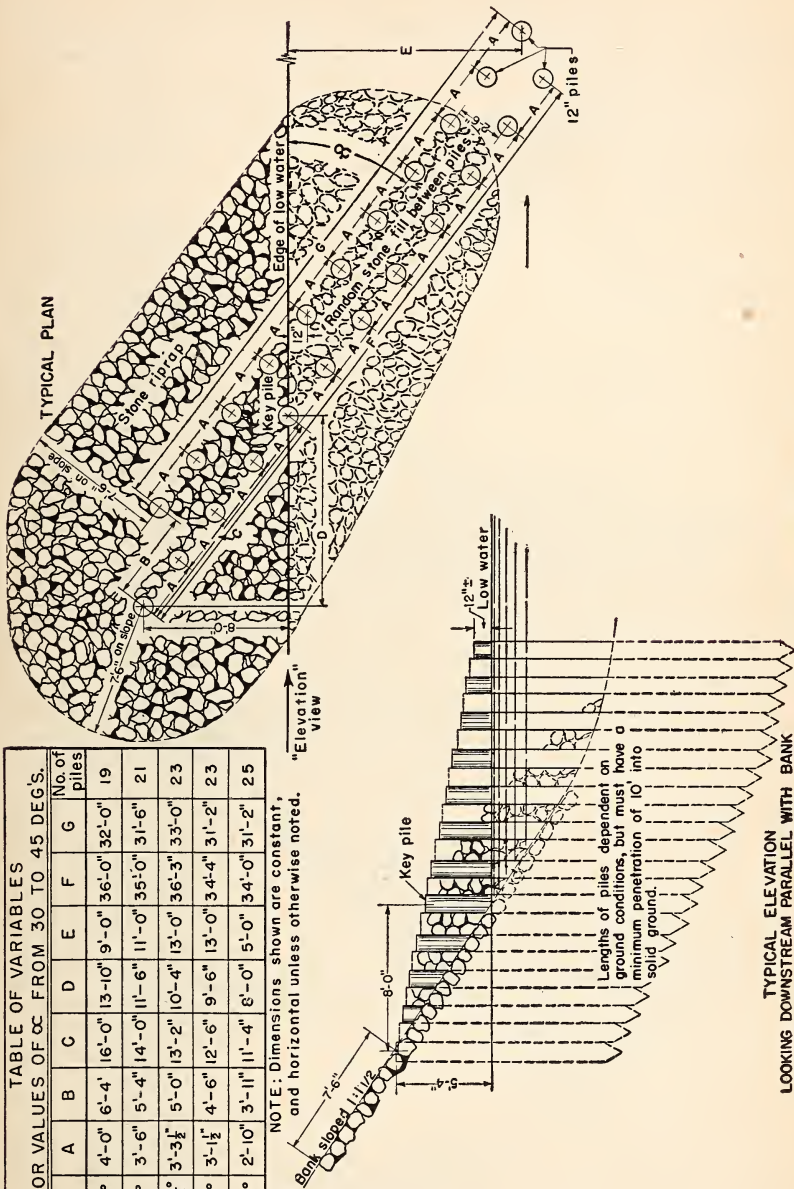
Figure 20 shows a typical plan for a semipermeable pile jetty, with dimensional details for different bank-jetty angles. Other types of jetties that have been used are wing-crib jetty (fig. 21) and the wire-bound rock or sausage type (fig. 22).

FIGURE 20.—Semipermeable pile jetty.

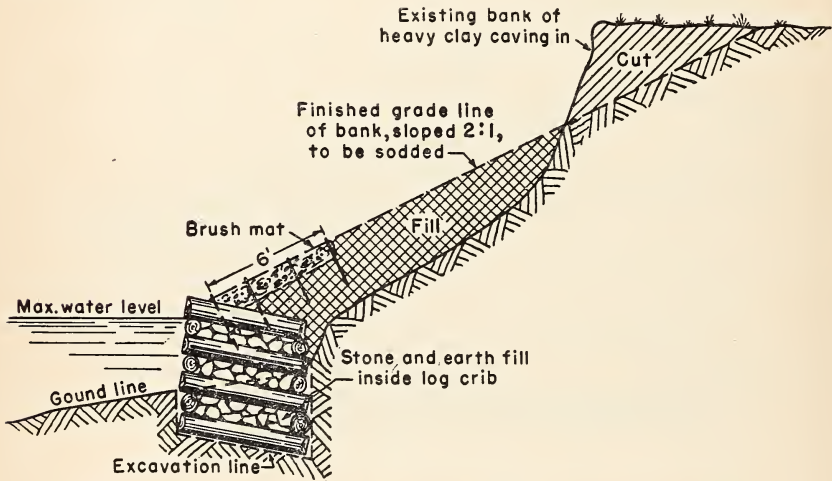
A stone-filled crib may also be used to protect the toe of bank slopes (fig. 24).

FIGURE 24.—Stone-filled log crib used for toe-of-slope protection.

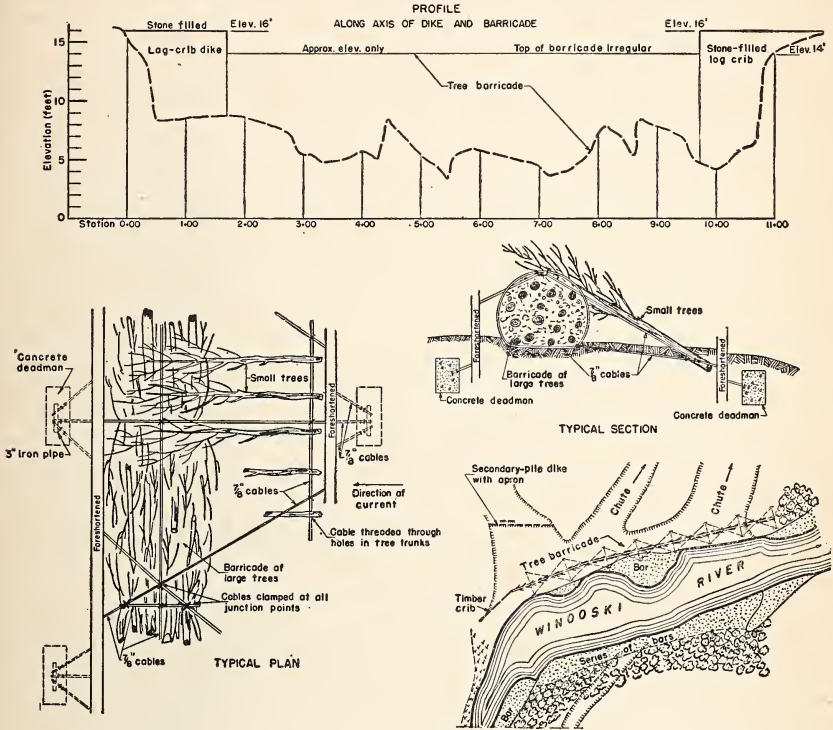
Tree barricades (fig. 25) are particularly applicable where the river is threatening to form one or more new channels and where conditions are not severe enough to warrant the construction of a stone-filled log crib, or where the length of bank needing protection makes the expense of a stone-filled log crib prohibitive.

FIGURE 25.—High-water tree barricade.
